## RESIDENTIAL REPORT

123 Merry Street  
CARBONDALE PA 18407

FEBRUARY 26, 2019

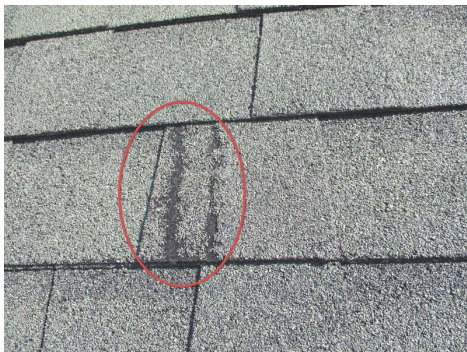
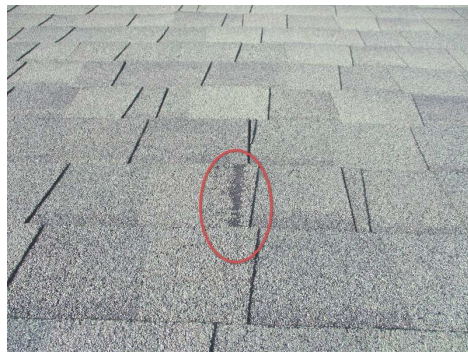
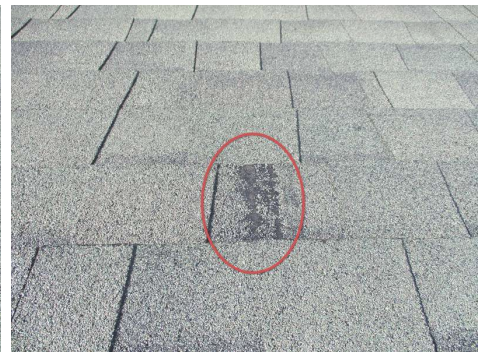
#### **COSMETIC DAMAGE**

One or more areas on the roof showed signs of minor cosmetic damage caused during install or manufacturing defect. I recommend monitoring those particular areas as they are more susceptible to faster degrading and future roof leaks.

Recommend monitoring.

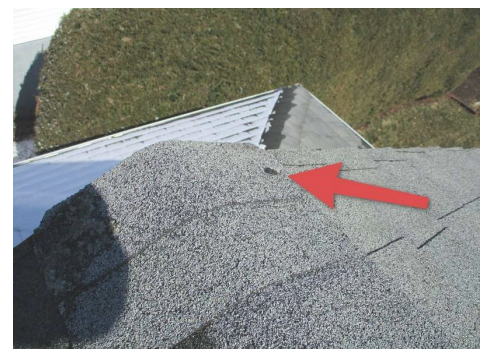
### 2.1.2 Coverings

#### **EXPOSED FASTENERS**

One or more roof fasteners were not covered by the correct roofing materials. I recommend keeping the fasteners sealed and monitoring for future signs of leaks.

Recommended DIY Project

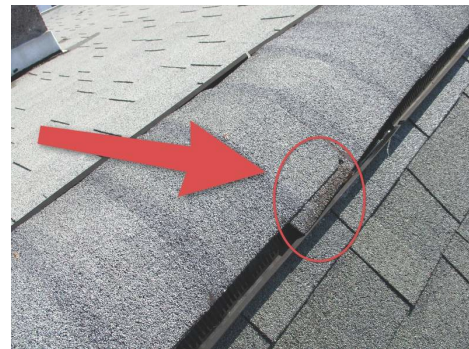
### 2.1.3 Coverings

#### RIDGE CAP DAMAGED

One or more areas on the ridge cap, which is the uppermost part of your roof, were "slipping". I recommend contacting a qualified roofer in order to make the necessary repairs in order to avoid future leaks.

Contact a qualified roofing professional.

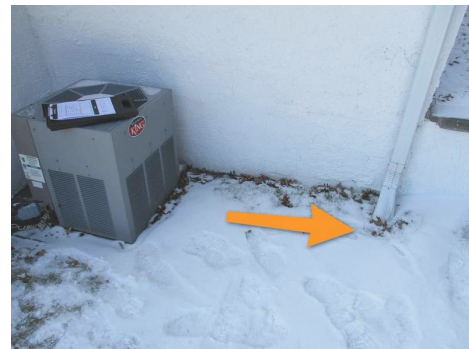
### 2.2.1 Roof Drainage Systems

#### DOWNSPOUTS DRAIN NEAR HOUSE

One or more downspouts drain too close to the home's foundation. This can result in excessive moisture in the soil at the foundation, which can lead to foundation/structural movement. I recommend adjusting downspout extensions to drain at least 6 feet from the foundation.

Contact a handyman or DIY project

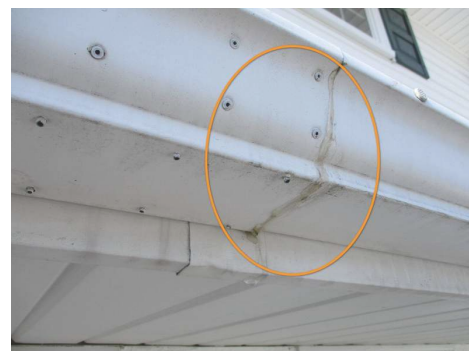
### 2.2.2 Roof Drainage Systems

#### GUTTER LEAKAGE

Gutters were observed to be leaking in one or more areas. This can result in excessive moisture in the soil at the foundation, which can lead to foundation/structural movement. I recommend sealing with a rubber based caulk from the inside of the gutter during a dry period in order to prevent further leakage.

Contact a handyman or DIY project

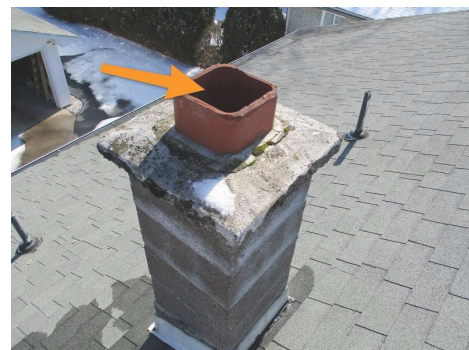
### 2.4.1 Skylights, Chimneys & Other Roof Penetrations

#### CHIMNEY UNLINED

The single flue chimney was unlined and used with a natural gas heating appliance, which can deteriorate the chimney structure over time, and allow harmful gasses to enter home. I recommend a qualified masonry or chimney contractor evaluate and install the proper chimney liner.

Contact a qualified chimney contractor.

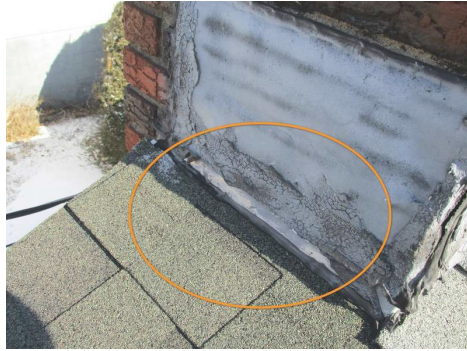
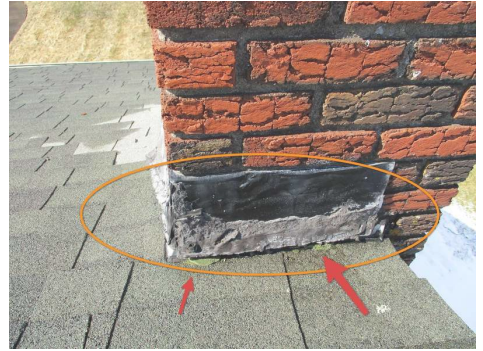
### 2.4.2 Skylights, Chimneys & Other Roof Penetrations

#### STEP FLASHING NEEDS REPAIR

The step cracking around the base of the double chimney, is showing signs of separation, which can cause leaks into the roof structure. I recommend contacting a qualified roofer or chimney professional in order to re-flash and seal the area.

Contact a qualified professional.

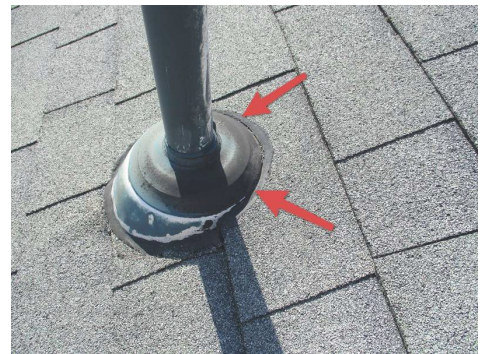
#### 2.4.3 Skylights, Chimneys & Other Roof Penetrations

##### **PLUMBING BOOT NEEDS REPAIR**

One or more plumbing "boots" showed signs of wear around the seals. I recommend resealing around the "boot" using roofing caulk in order to prevent future roof leaks.

Contact a handyman or DIY project

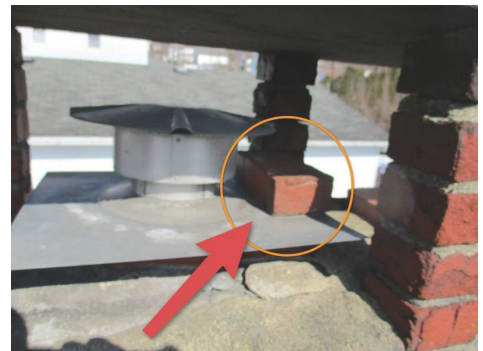
#### 2.4.4 Skylights, Chimneys & Other Roof Penetrations

##### **IMPROPER CHIMNEY CAP**

The rain cap around one of the flues on the double chimney was secured using a loose brick, which may cause the cap to become dislodged during heavy winds. Although a proper chimney cap was installed around the entire chimney, I recommend properly securing the rain cap in order to prevent unwanted moisture intrusion between the chimney liner and brick structure.

Contact a qualified professional.

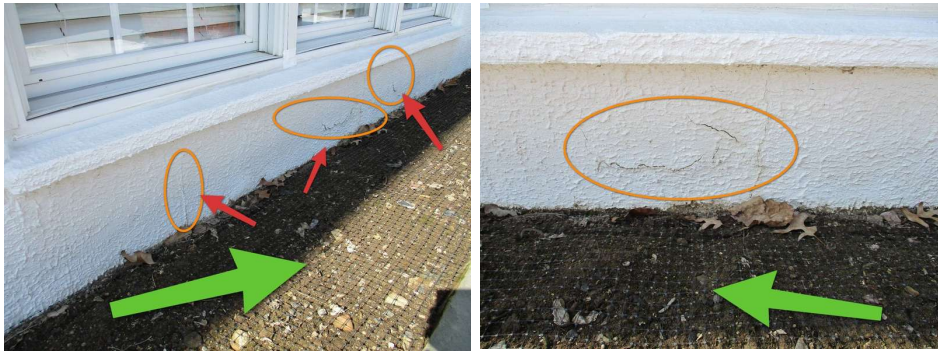
SPALLING

One or more areas on the exterior masonry covering showed signs of spalling. Spalling is the separation of the foundation material from the exterior finishing material, and is caused by moisture entering the masonry material. In this case, it appears the moisture is being wicked up from the surrounding dirt from the garden area. I recommend either removing the dirt from around the foundation or installing a plastic sheet liner in between the dirt and foundation.

Contact a handyman or DIY project

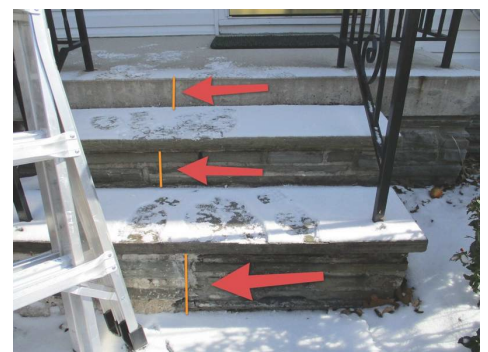
### 3.4.1 Decks, Balconies, Porches & Steps

#### **UNEVEN STEPS**

One or more steps on the front porch are uneven and pose a possible trip hazard.

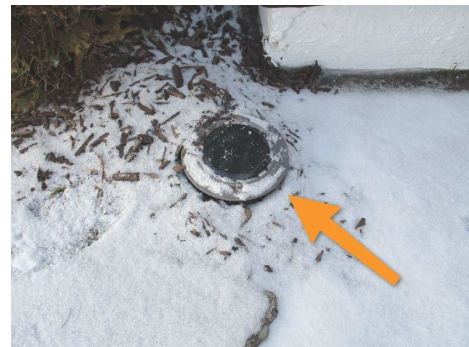
### 3.7.1 Pest Treatment Evidence

#### **TERMITE TREATMENT EVIDENCE**

Several termite bait cartridge stakes were noted to be installed around the perimeter of the home. The particular ones observed were of the same variety that are usually installed by professional pest management companies. The presence of the stakes indicate that treatment of termites was performed at the home at some point in the past. Although no other evidence of termites, or active infestation was observed, I recommend contacting the seller of the home to inquire about past termite activity or attempted treatment.

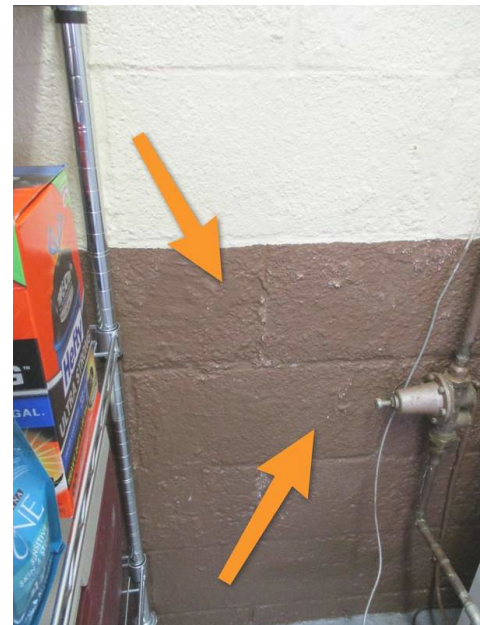
Efflorescence was noted on the basement wall surface. This is a white, powdery deposit that is consistent with moisture intrusion. I recommend monitoring and/or correction to any grading outside that may contribute to this issue. It is also noteworthy, that some basements, no matter the grading, will always have above average levels of moisture. In this case, I recommend placing a dehumidifier in the basement to keep moisture levels manageable.

Recommend monitoring.

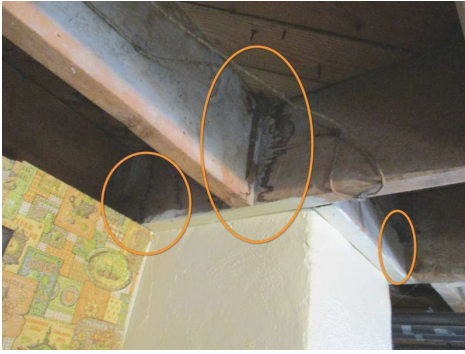
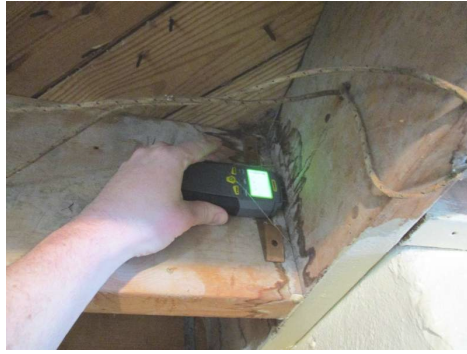
#### 4.3.1 Floor Structure

##### LEAK-INACTIVE

One or more areas in the ceiling (flooring of second floor) structure were observed to be stained from a leak above. Although the leak does not appear to be active at this time, I recommend consulting the current homeowner if possible and monitoring the area to prevent further leaks.

Recommendation  
Recommend monitoring.

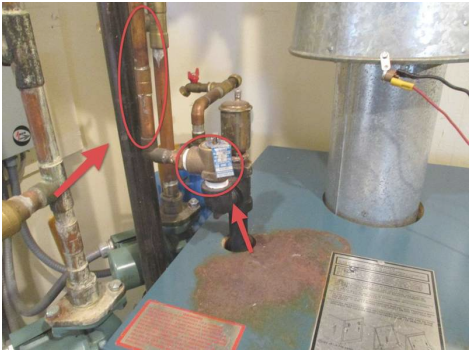
The TPR valve on the natural gas boiler was not properly installed, which can create unnecessary resistance to any steam/water discharge in the event the valve needs to be used. The valve should extend directly to the side of the boiler and down, terminating within 6 inches of the floor. I recommend contacting a qualified plumber to repair as needed.

Recommendation  
Contact a qualified plumbing contractor.

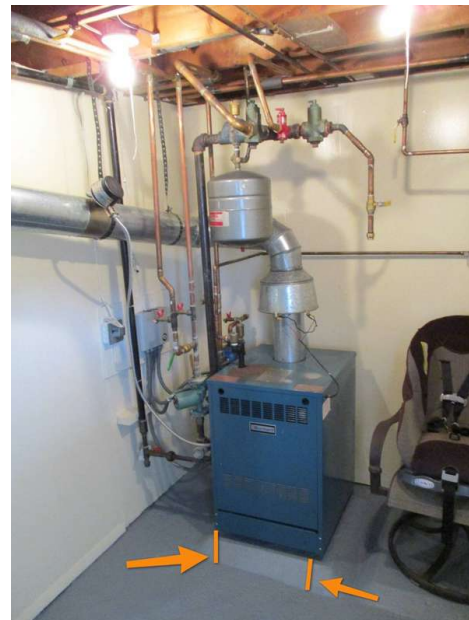
5.1.2 Equipment

GAS APPLIANCE IMPROPER GROUND CLEARANCE

The natural gas boiler located in the garage lacked the proper ground clearance of 18 inches, which can create a combustion/fire hazard. I recommend contacting a qualified HVAC technician to evaluate and relocate the appliance as needed.

Recommendation  
Contact a qualified HVAC professional.

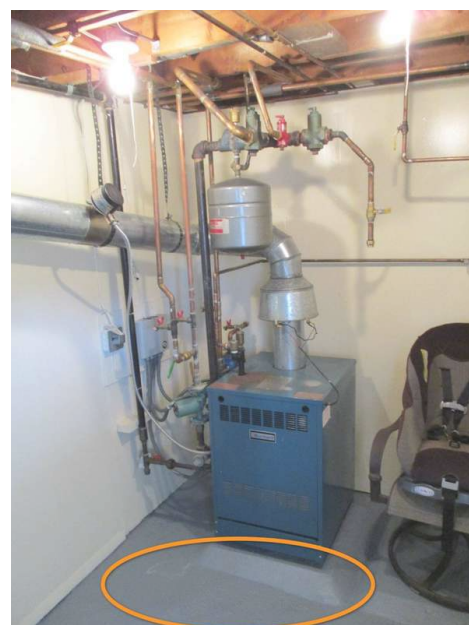
#### 5.1.3 Equipment

### **GAS APPLIANCE - NO SAFETY BARRIER**

The natural gas boiler located in the garage lacked the recommended safety barriers. This can create a fire/explosion hazard if a vehicle were to strike the heating unit. I recommend contacting a qualified contractor to install a proper safety barrier around the unit.

Contact a qualified professional.

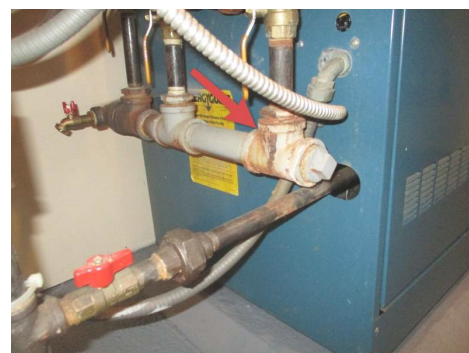
#### 5.3.1 Distribution Systems

### **LEAKING PIPE ON BOILER**

A hot water distribution "T" connection on the boiler had evidence of a past leak. I recommend contacting a qualified plumber in order to evaluate and repair pipe as needed.

Contact a qualified plumbing contractor.

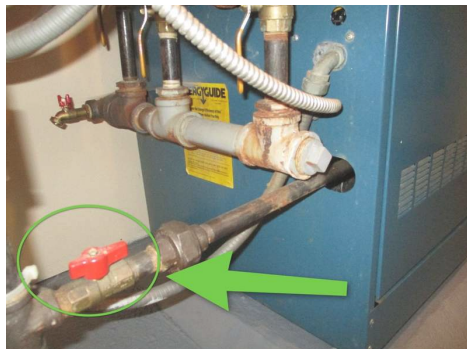
### **LOCATION**

The fuel shut-off for the gas boiler is located to the left of the boiler. I have highlighted the shut-off for your convenience.

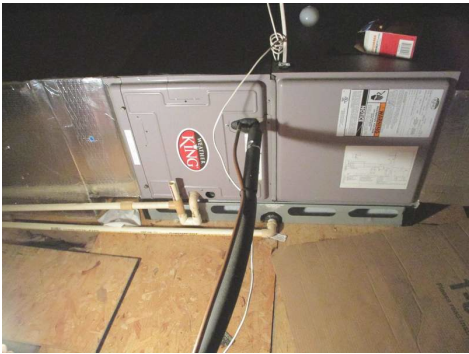
Air Conditioning Air Handlers like the one installed in the home are designed to last approximately 15 years. The unit present during the inspection was 15 years or older, which means it can fail at any time. I recommend replacing the unit in the near future.

Contact a qualified HVAC professional.

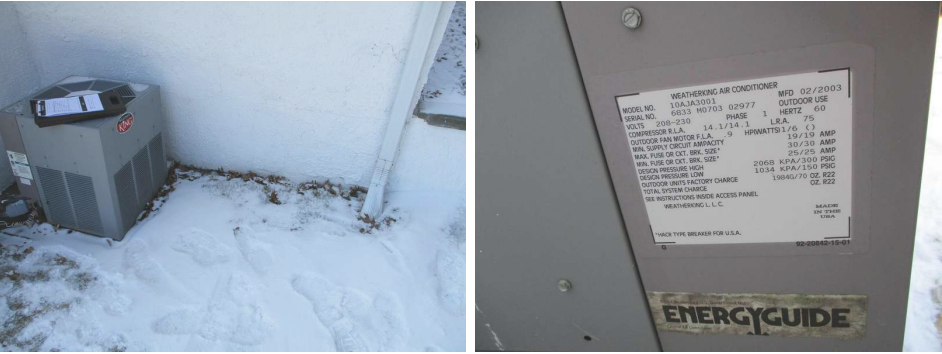
6.1.2 Cooling Equipment

**\*\* BEYOND EXPECTED LIFESPAN \*\* A/C CONDENSER/COMPRESSOR**

Air Conditioning Condenser/Compressor units like the one on the exterior of your home are designed to last approximately 15 years. The unit present during the inspection was 15 years or older, which means that it could fail at any time. I recommend replacing the unit in the near future.

Recommendation  
Contact a qualified HVAC professional.

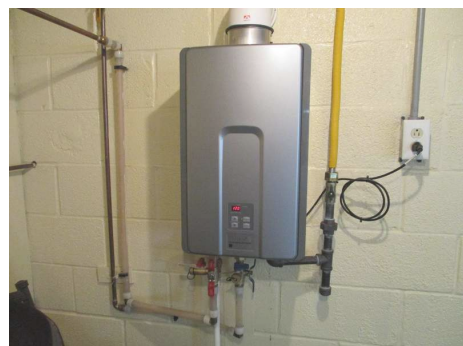
#### Hot Water Systems, Controls, Flues & Vents: Picture of Unit

Attached Garage

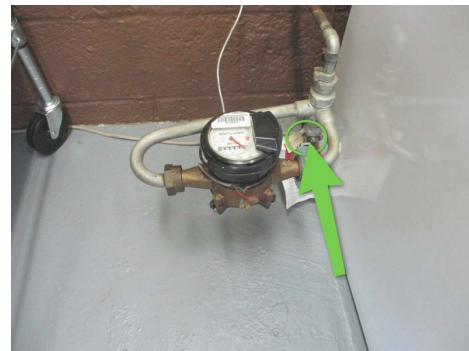
#### MAIN WATER SHUT-OFF LOCATION

The main water shut-off valve is located in the tucked-in garage, in the rear. I have highlighted the shut-off for your convenience.

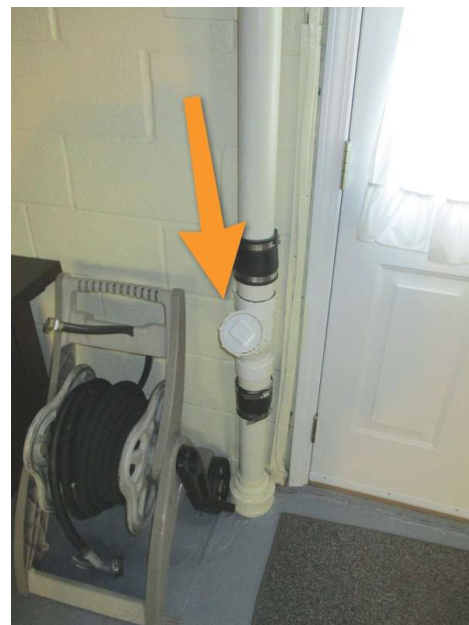
#### LOCATION OF MAIN WASTE DRAIN PIPE

The location of the main waste drain pipe is in the attached garage to the left of the garage door. The cleanout cap appears to be in good condition and in working order.

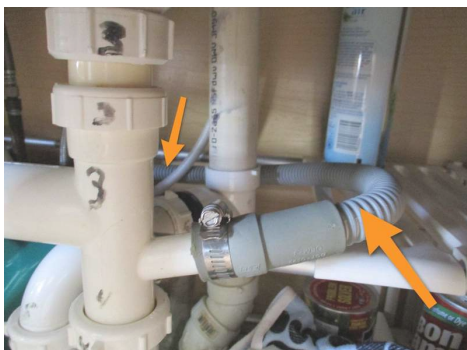
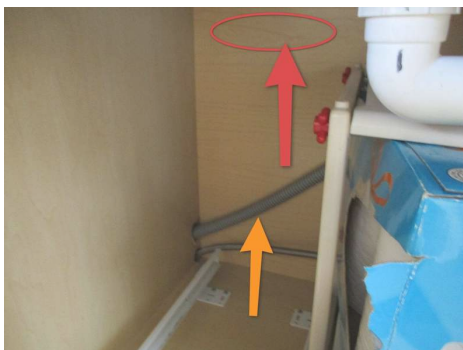
### 7.3.1 Water Supply, Distribution Systems & Fixtures

#### DISHWASHER - NO "HIGH-LOOP"

Dishwashers are required to be installed using a "high-loop" in their drain line. That is, prior to entering into the main drain pipe underneath sink, the drain tube should extend upwards at least 32" and then proceed to the drain. This is recommended in order to prevent backflow from the drain into the dishwasher itself. I recommend either a plumber or DIY'er install a proper "high-loop".

Contact a handyman or DIY project

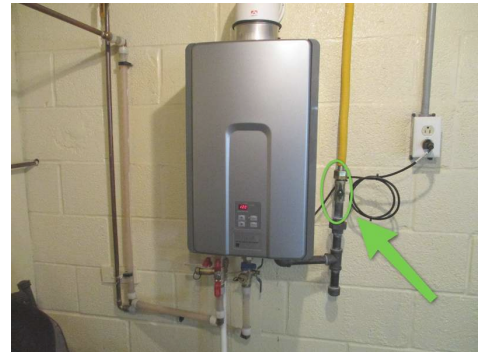
**FUEL SHUT-OFF LOCATION**

The fuel shut-off for the tankless water heater is located to the right of the unit. I have highlighted the shut-off for your convenience.

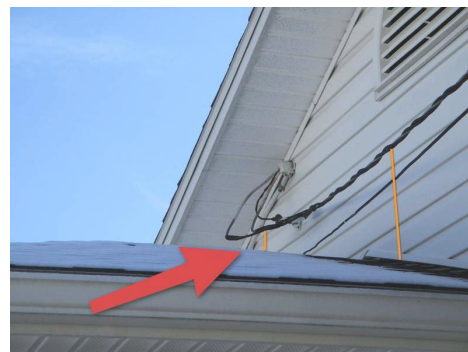
## 8.1.2 Service Entrance Conductors

**NOT ENOUGH CLEARANCE**

The electrical service drop overhead wires are too low, not giving the recommended 3 foot clearance to the roofline. I recommend contacting a qualified electrician in order to install a taller electrical service mast to increase clearance.

Contact a qualified electrical contractor.

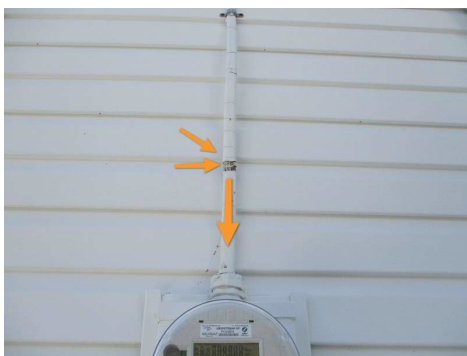
## 8.1.3 Service Entrance Conductors

**WATER INTRUSION**

The frayed electrical service wire is allowing moisture to enter into the meter housing, as evidenced by rust near the bottom of the meter. I recommend the wire be replaced as soon as possible in order to prevent moisture from entering the wire housing or the meter base itself.

Contact a qualified electrical contractor.

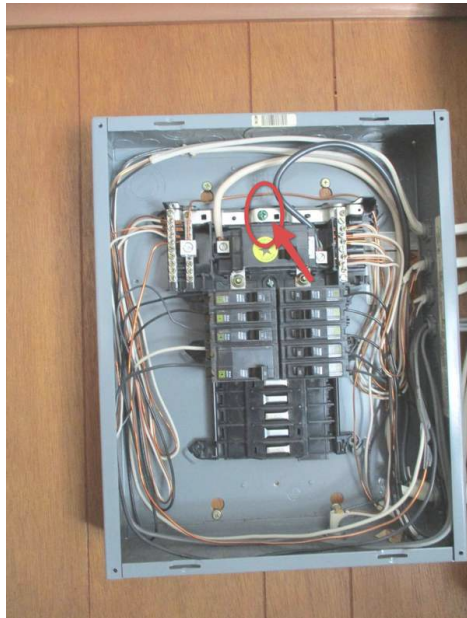
#### 8.2.3 Main & Subpanels, Service & Grounding, Main Overcurrent Device

##### **SUB-PANEL - NO BONDING**

The sub-panel was not correctly bonded to the panel cabinet. I recommend contacting a licensed electrician to evaluate and install a

Contact a qualified electrical contractor.

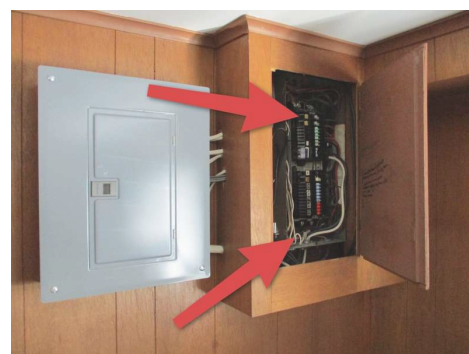
8.2.6 Main & Subpanels, Service & Grounding,  
Main Overcurrent Device

### PANEL COVER MISSING

The main electrical service panel was missing its factory cover, which leaves live electrical elements exposed. I recommend using caution around the panel until the panel is replaced and fitted with the proper cover.

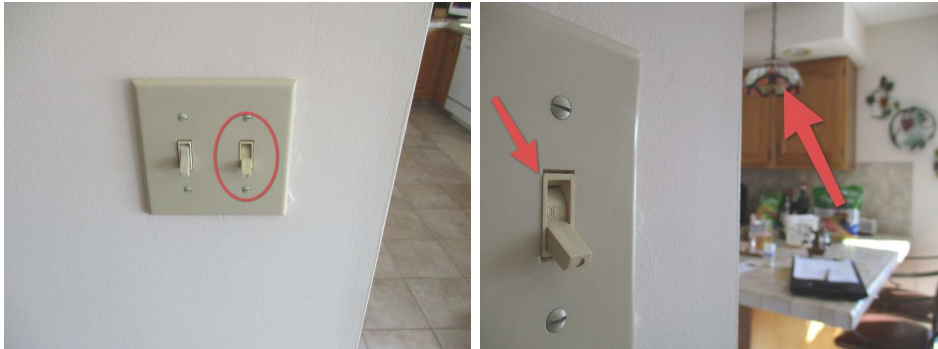
8.4.1 Lighting Fixtures, Switches & Receptacles

### FAULTY SWITCH

The light switch that controls the light over the kitchen counter was faulty. When switched on, the switch housing creates muted "sparking" sound, which indicates loose connections. The light also flickers. These conditions can create a fire or shock hazard. I recommend replacing the faulty switch or contacting a qualified electrician to do so.

Contact a qualified electrical contractor.

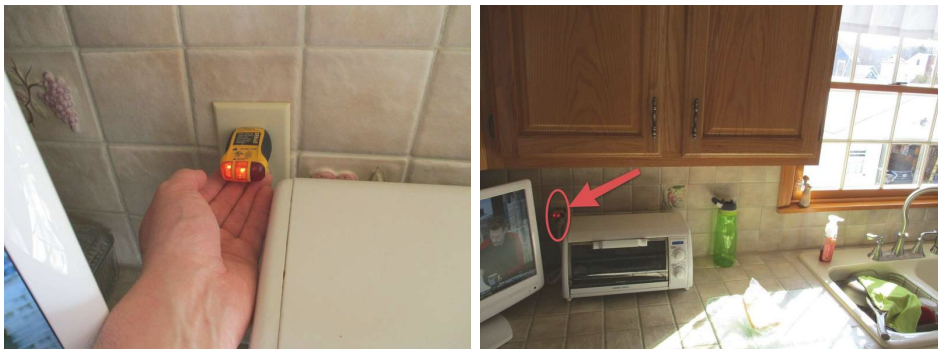
#### 8.5.1 GFCI & AFCI

### NO GFCI - KITCHEN

One or more outlets in the kitchen were not GFCI protected, resulting in potential shock hazards. GFCI protection is required to be installed in all kitchen outlets. I recommend contacting a licensed electrical contractor to evaluate and install proper GFCI outlets in all kitchen areas.

Contact a qualified electrical contractor.

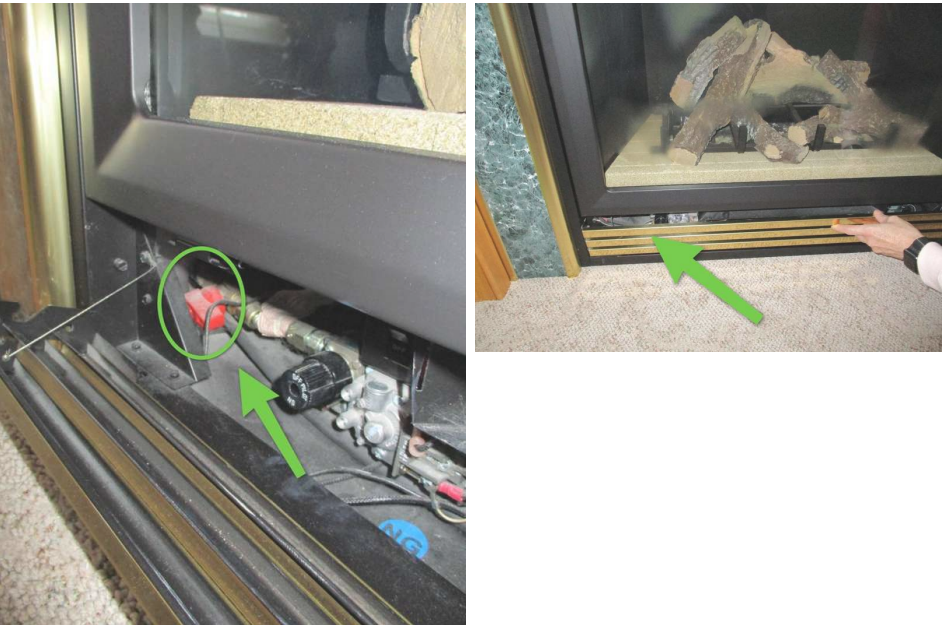
FUEL SHUT-OFF LOCATION

The main fuel shut-off for the gas fireplace was located in the control panel underneath the unit. I have highlighted the shut-off for your convenience.

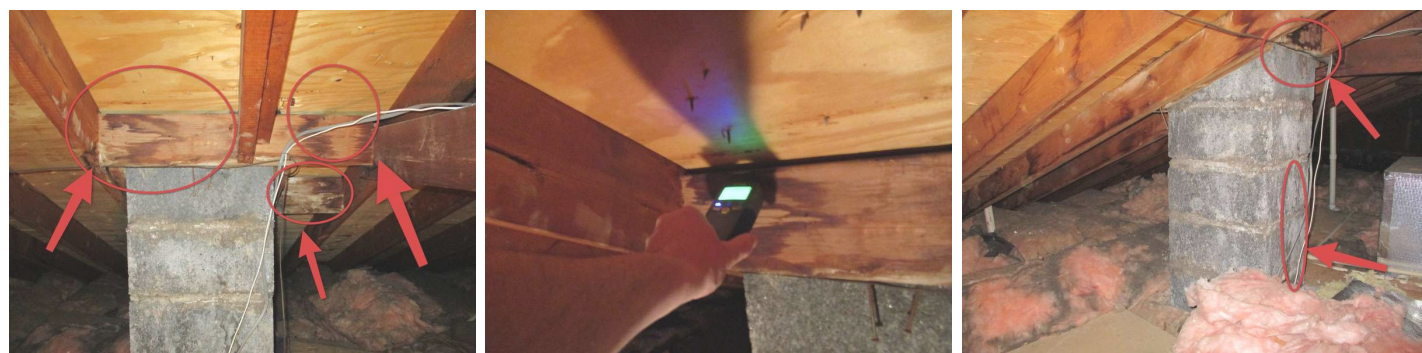
#### LEAK EVIDENCE - INACTIVE

The area around the chimney showed signs of a past leak. The moisture meter revealed the area was dry, which may indicate the leak has been repaired. I recommend contacting the sellers of the property to inquire about any past leaks or repairs made. Also, monitor area closely to detect early signs of any future leaks.

Recommend monitoring.

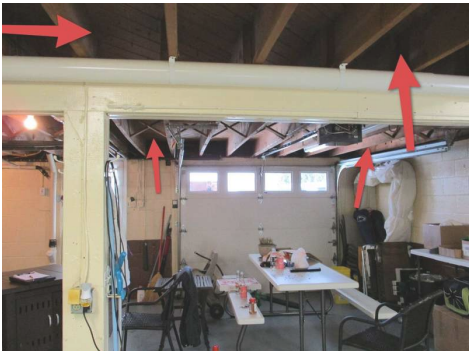
It is recommended that all garages that are attached to homes, have an adequate firewall to prevent the spread of fire from the garage area, to any living areas. An adequate firewall consists of drywall on all walls and ceilings abutting any living areas. In addition, any doors leading to living areas, must be constructed of metal/steel at least 1 3/8-inch thick or a 20-minute fire-rated door. Although no vehicles were currently being stored/parked in the garage, I recommend contacting a general contractor in order to install a proper firewall in the garage if the garage were to be used to park vehicles in the future.

Recommendation  
Contact a qualified general contractor.

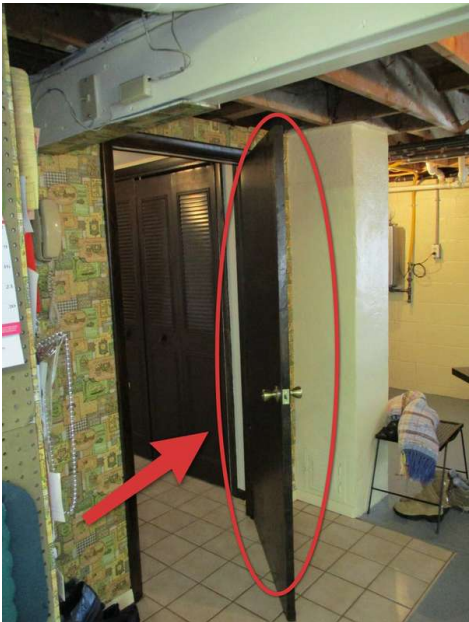
12.4.1 Occupant Door (From garage to inside of home)

NO FIREWALL - DOOR

It is recommended that all garages that are attached to homes, have an adequate firewall to prevent the spread of fire from the garage area, to any living areas. An adequate firewall consists of drywall on all walls and ceilings abutting any living areas. In addition, any doors leading to living areas, must be constructed of metal/steel at least 1 3/8-inch thick or a 20-minute fire-rated door. Although no vehicles are currently being parked/stored in the garage, I recommend contacting a general contractor in order to install a proper firewall in the garage if it were to be used as a storage/parking area for any vehicles.

Recommendation  
Contact a qualified general contractor.
